SAND97–2791 • UC–1244 Unlimited Release Printed November 1997

Monitored Performance of Residential Geothermal Heat Pumps in Central Texas and Southern Michigan

William N. Sullivan

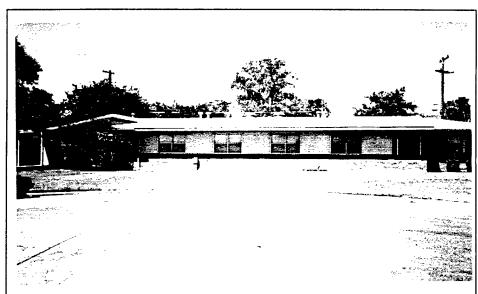
Figure 1. Typical duplex residence in the Montague subdivision at Ft. Hood

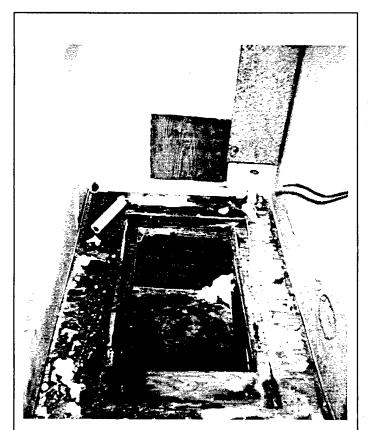
Figure 5. Utility closet with original furnace/air handler removed.

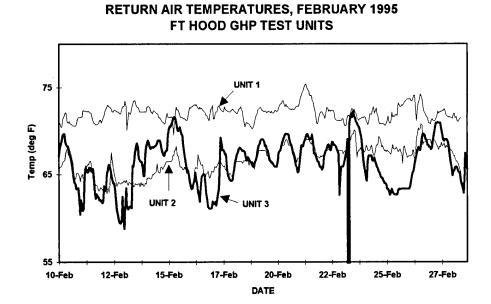
The return air temperature at the air handler/heat pump intake plenum is a measure of home interior temperature. Figures 8 and 9 show typical variations in the return air temperatures for the three GHP homes for both winter (February, 1995) and summer (June, 1996) conditions. Not surprisingly, all the test homes are maintained at different interior temperatures based on the tastes of the individual residents. Most of the homes are roughly comparable, however, with the exception of the unit 3 GHP which exhibited unusually large variations in interior temperature in both the winter and summer.

Figure 8. Winter return air temperature, GHP test units

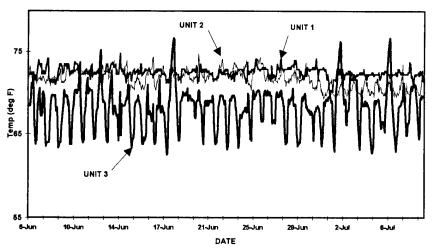
There was no indication from the return air data that either the heat pumps or the conventional HVAC hardware could not maintain desired temperature levels in these homes for essentially all the weather conditions encountered during the test.

Figure 9. Summer return air temperature, GHP test units

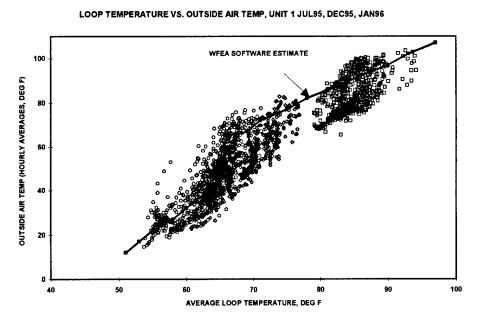
A more detailed comparison with the theoretical predictions of loop temperature is given in Figure 11. In this figure, a scattergram for unit 1 is created with hourly average pairs of outside air temperature and loop temperature. The WFEA software assumes a simple relationship between outside air temperature (related to building thermal load) and loop temperature. The design software results, also shown on Figure 11, reasonably average the scatter points. Exact matching cannot be expected, of course, because the loop temperature at any given time depends on the building load and thermal load history of the loop. For example, with the same outside air temperature, loops run hotter at the end of the summer than

Figure 11. Measured loop temperatures compared to WFEA software prediction

at the beginning because of soil heating near the loop. Another notable difference between the analysis and this installation is the total bore length used for the analysis (660 ft) and this test unit (750 ft). Use of the as-built loop length in the analysis would reduce the maximum loop temperature by about 6 °F and raise the minimum by a similar amount. Considering the general uncertainty about actual system loads and the thermal conductivity of this site, the WaterFurnace loop design software has done a good job of matching the loop temperatures observed at this site.

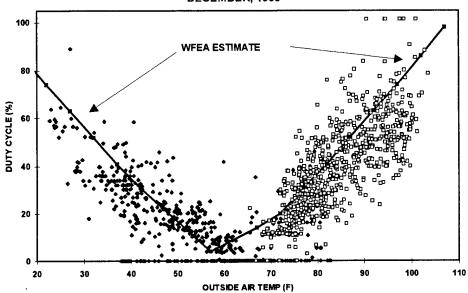
Figure 12 is a scattergram of hourly average duty cycle vs. hourly average outside air temperature for unit 1 operating over the months of July and December, 1995. Also shown is a prediction from the WFEA software. This prediction is based on the peak design calculations for heating and cooling loads. For these data, covering a range of outside air temperatures between 20 and 100 °F, the "average" duty cycle is well below 100 %, although there are individual points approaching 100 %. This indicates that the sizing of the heat pumps falls between "just right" and oversized.

Not shown on Figure 12 is the duty cycle for the auxiliary resistance heaters because measurements indicated essentially no demand for resistance heat on units 1 or 2 for the entire test period. As mentioned above, unit 3 had the unusual behavior of operating almost entirely on resistance heat through both heating seasons. We assume this is because the thermostat switch was set on "Emergency Heat" by the residents. Unfortunately, we were not able to confirm this directly with the residents or gain access to the heat pump unit, although our instruments indicated the unit 3 heat pump compressor was functioning properly. It is possible that an internal malfunction in the heat pump could yield the same result.

Figure 12. Hourly average duty cycle for unit 1 GHP. The solid points correspond to heating conditions, the open points for cooling.

- 1. Use smaller heat pump units. The duty cycle data indicate that the units in this test easily satisfied peak loads. We believe that similar efficiency units with reduced capacity, by approximately 1/2 ton (6000 Btu/hr), would also be able to satisfy the loads. Smaller units would also further reduce peak demand.
- 2. Reduce loop length. This suggestion is based on the moderate max/min loop temperatures observed on this test. We would recommend only a modest reduction, however, from 750 to 700 ft. for the larger homes and 750 to 650 ft. for the smaller ones.
- 3. Use desuperheaters to provide domestic hot water. As mentioned in the design section, this was not an option for the Montague homes under test due to the layout of the homes. It may be possible for other homes at Ft. Hood.

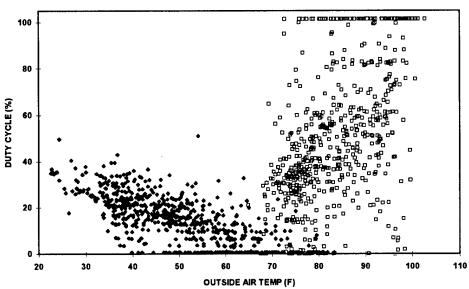
Figure 13 shows a similar scattergram for the unit 2 gas furnace and air conditioner. The conventional AC operates at near 100% duty cycle when the air temperature is above 90 °F. This indicates that the conventional AC equipment is somewhat undersized and falls short of removing the peak cooling load on this unit. The gas furnace, alternatively, has no problem following the heating load. This is expected because the heat output of this 75,000 Btu/hr input furnace greatly exceeds the calculated peak heating load.

Figure 13. Hourly average duty cycle for unit 2 furnace and AC

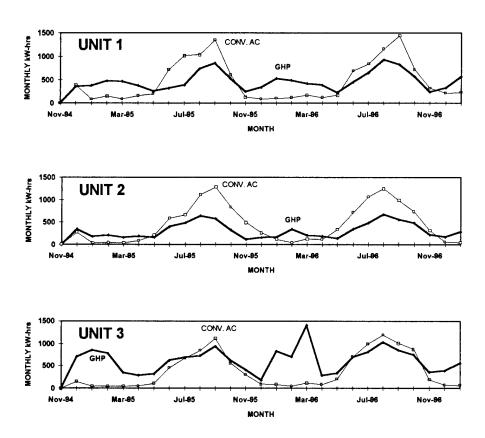
Figure 14. Monthly HVAC electrical energy use for GHP and conventional units at Ft. Hood. Conventional AC air handler energy not included in these figures.

The monthly electrical energy consumption for the GHP and conventional HVAC systems is summarized in Figure 14. It is clear from these plots that with the exception of unit 3, the GHP systems offer considerable savings in energy use, particularly during heavy use months in the summer.

The high energy use of unit 3 has been previously discussed. The high use of resistance heat has a large, obvious impact on the winter heating energy use. The relatively high energy use of unit 3 in the summer is due to the low interior temperatures the residents prefer and the frequent thermostat changes made. In some cases, unit 3 actually operated in heating mode in the summer to follow changes evidently demanded by the thermostat.

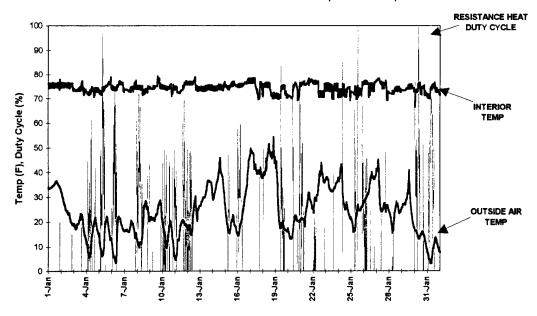
From the degree-days shown in Figure 21, it is apparent that one of the coldest months during the entire test period was January, 1995. Figure 22 and 23 indicates the behavior of unit 1 during that month. Figure 22 shows that the interior temperature (measured on the wall at the thermostat location) was maintained at about 75 °F throughout the month, which included low outside air temperatures approaching 0 °F. The instruments indicated, however, that in order to maintain comfort when outside

air temperatures were low, a 5kW auxiliary strip heater was frequently used. This is consistent with the predictions of Table 5 which indicates that resistance heat will be needed when outside air temperatures fall below 17 °F. The auxiliary strip heat was rarely operated at 100% duty cycle, even under the coldest conditions, which would indicate that the heat pump with its auxiliary heater is adequately sized to carry the load.

Not shown in Figure 22 for clarity is the compressor duty cycle, but the measurements indicated that the compressor operated for approximately 80% of the time during this month and during cold periods the compressor would operate continuously for days at a time. This is, of course, exactly what the systems were designed to do. This is not the normal mode of operation for a residential forced air heating system and this led one resident to complain to us that the system "runs constantly" although they acknowledged that the home was comfortable during cold weather.

Figure 22. Unit 1 performance, showing strip heat duty cycle, outside air temperature, and interior room temperature.

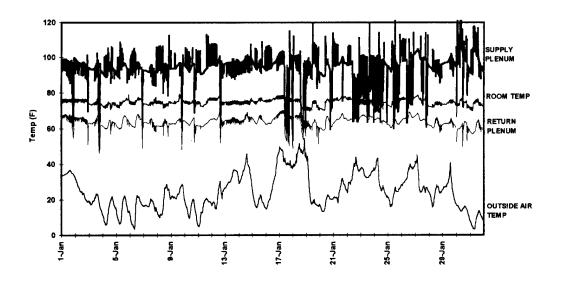
Figure 23. Supply and Return plenum temperatures for unit 1, Selfridge, MI, January, 1996

The supply and return air temperatures at the heat pump are indicated in Figure 23 for the same period. More detailed analysis of the data shows that during a cold month like this, the heat pump operating without auxiliary strip heat would yield supply air in the range of 100-105 °F. With the added heat from the strip heaters, plenum temperatures rise to the 110-115 °F range. It is apparent from Figure 23 that there is a trend toward rising supply air temperatures as the month proceeds. This trend is simply due to loss of air handler flow from the progressive clogging of the air filter and continued through May 1996 when the filters were belatedly changed. Changing the filter restored the supply temperatures to the 100-105 °F range.

One other observation from Figure 23 is the approximately 10 °F reduction in temperature between the room air temperature at the thermostat and the return air plenum temperature. Part of this reduction may be explained by the normal floor-to-ceiling thermal gradient, and the fact that the return air registers are at floor level. We suspected, however, that duct losses were the major cause. A more detailed look at duct losses is summarized in Figure 24, covering a cold two day period in February 1996 when the outside air temperature ranged from -5 to 15 °F.

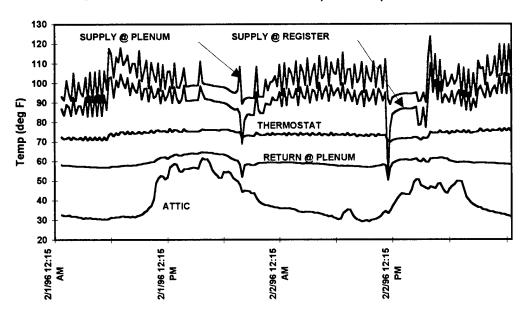
Figure 24. Temperatures in various parts of the duct system in unit 1 with outside air temperatures from -5 to 15 °F.

Figure 24 shows air temperature data in the supply plenum, at a bedroom ceiling mounted supply register, at the wall mounted thermostat, in the return air plenum, and in the attic space near the garage. The temperature drops in the ducts suggest that there is substantial loss of energy through this duct system. Both the supply and return duct systems are losing the order of 10 °F in air temperature across their length. Because the total difference in air temperature supplied by the heat pump and resistance heaters is about 50 °F, the duct loss observed in this figure is the order of 20% of the GHP energy supplied to the home. This estimate is an upper bound on the loss, of course, because outside air temperatures are not normally this cold.

Another issue concerns the duct losses that were observed in this installation. The duct losses approach 20% under very cold conditions and losses under these conditions will almost certainly be supplied by resistance strip heat since the capacity of the heat pump is limited. It is conceivable that if the duct losses were reduced significantly on these installations, the demand for auxiliary strip heat would approach zero.

One of the principal findings of the test program was the significant energy lost through the ducts in this installation. Reducing the duct losses would significantly reduce the use of the auxiliary strip heaters and the overall thermal load on the heat pump system. Indeed, we do not recommend replication of this installation without improvements to the ductwork insulation.

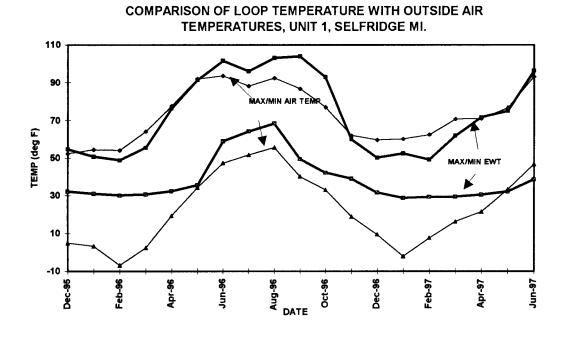
Figure 26. Loop temperature extremes measured for the test period

The minimum loop temperature during the winter appears to exhibit a floor at around 30 °F. We believe this is caused by local freezing of the ground water near the loops and the leveling of net thermal load into the ground because of the increasing use of resistance heat as outside temperatures fall. The improved thermal conductivity of ice and the large latent heat needed to freeze ice would strongly increase the net heat transfer per unit length of ground loop. This floor in loop temperature is even more obvious in Figure 27, a scattergram of 15 minute average loop temperatures vs. outside air temperature.

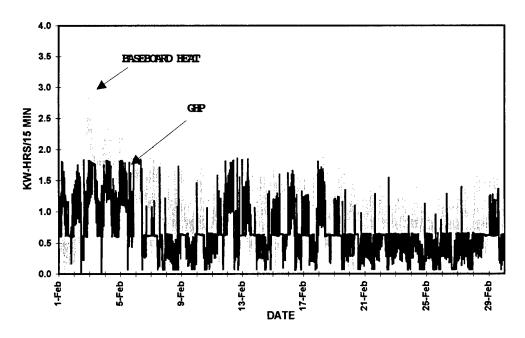
Figure 29. Peak HVAC demand for unit 1 GHP and resistance heat homes

The energy demand characteristic of the unit 1 GHP is compared to its adjoining resistance heat unit during a peak loading month (February, 1996) in Figure 29. As was the case with the Ft. Hood installation, a significant reduction in peak energy demand (approx. 40 % reduction in this month) is observed. The GHP demand curve, incidentally, clearly indicates two power levels corresponding to the compressor operating alone (peak of .6 kW-hrs/15 min) and the compressor plus strip heat (peak of 1.8 kW-hrs/15 min)
